CASE REPORT

# Double left ventricular pacing following accidental malpositioning of the right ventricular electrode during implantation of a cardiac resynchronization therapy device

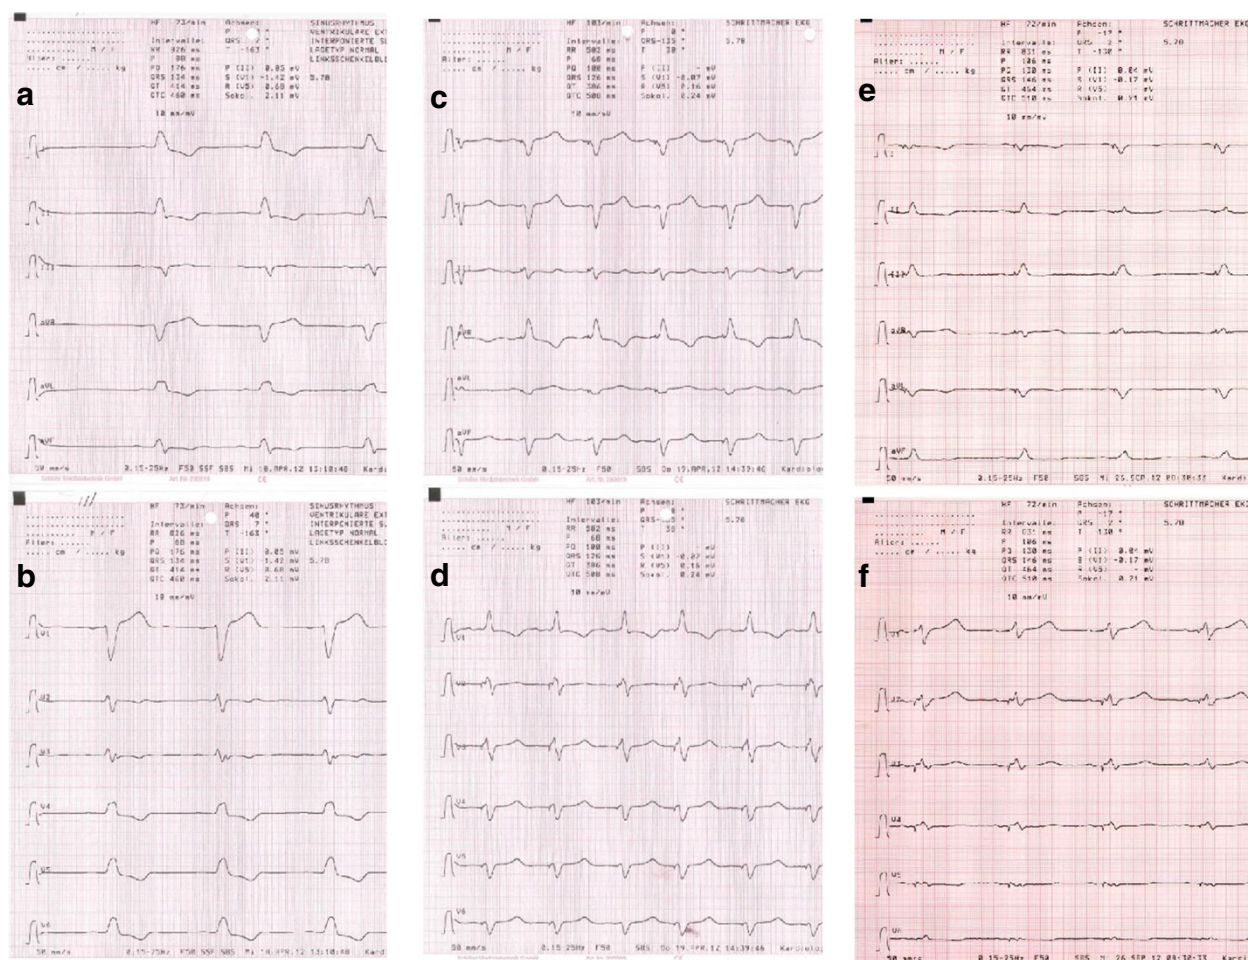
narrowed QRS complex (Figure 1c-d) with optimal values of all three electrodes (Table 1).

**Figure 1** ECC recordings before CRT implantation showed a wide QRS due to LBBB (1 a-b); after CRT implantation simultaneous stimulation of the presumed RV electrode misplaced in the left ventricle and the CS electrode resulted in a narrow QRS and positive R-waves in V1 (1 c-d); after revision of the RV lead simultaneous stimulation in the RV and the CS (1 e-f). Although the ECGs before and after revision show differences, the principle finding of a narrow QRS and a positive R-Wave in V1 is present in both recordings.

right heart without a sheath. A new electrode was advanced and fixed at the base of the right ventricle. Postprocedure chest x-ray (Figure 2c-d), ECG (Figure 1e-f), and measurements (Table 1) all documented good results. This time a postprocedure echocardiogram showed an intact mitral valve, persistent good left performance, and the RV electrode within the right heart.

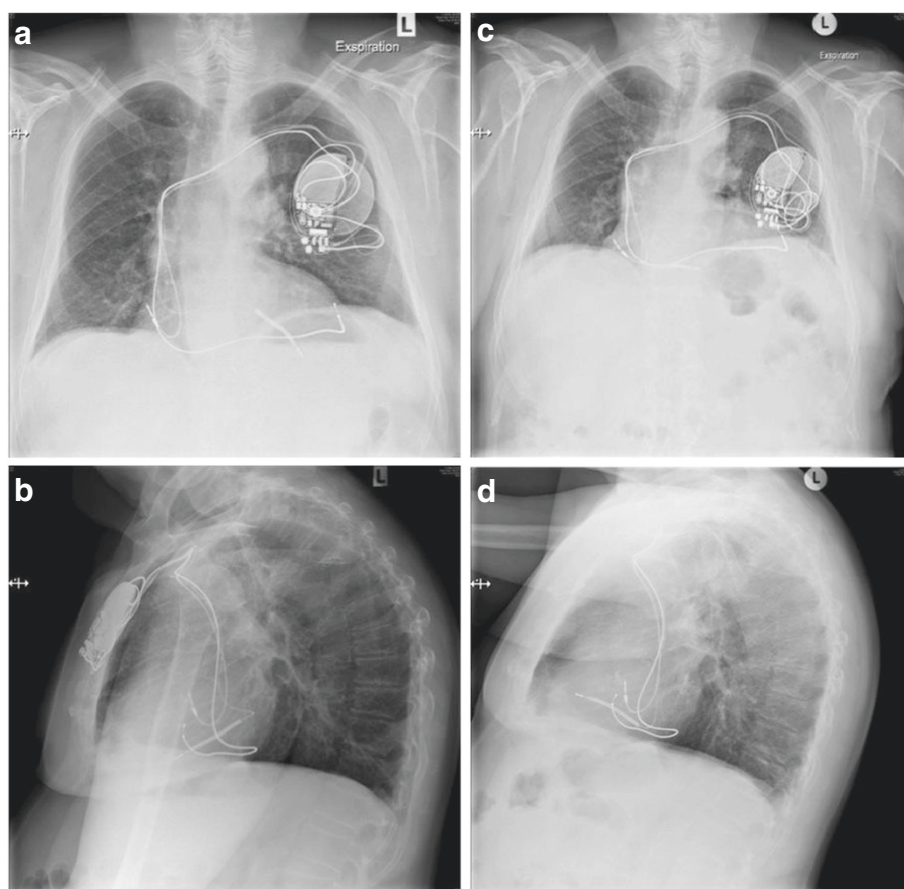
**Figure 2** Chest x-ray in the anterior and lateral view after the original CRT-ICD implantation (2 a-b) and after revision of the ICD lead (2 c-d). Atrial and CS electrodes remained unchanged. During revision the malplaced ICD electrode was removed and replaced in the RV. The chest x-ray after first implant was graded normal by routine judgement. In retrospective, the curve at the atrial level and the posterior orientation of the ICD lead may indicate passage of the foramen ovale and misplacement in the LV.

RV malplacement may be detected by postero-anterior and lateral chest radiographs in particular if the tip shows a posterior orientation [4,6,9]. However, diagnosis of RV malpositioning requires a high degree of suspicion [10]. In the present case, routine examination of chest x-ray (2a-b) was judged normal. By careful retrospective analysis, however, the RV lead curve is unusual and needs further investigation. In the present case, diagnosis of malplacement was made by transthoracic echocardiography 4 weeks after the implantation. Instead of transesophageal echocardiography, chest CT scan would be an alternative diagnostic possibility [10].

After studying the literature and informing the patient about possible consequences a revision procedure was performed. The RV electrode was easily removed from the left ventricle but could not be safely placed in the

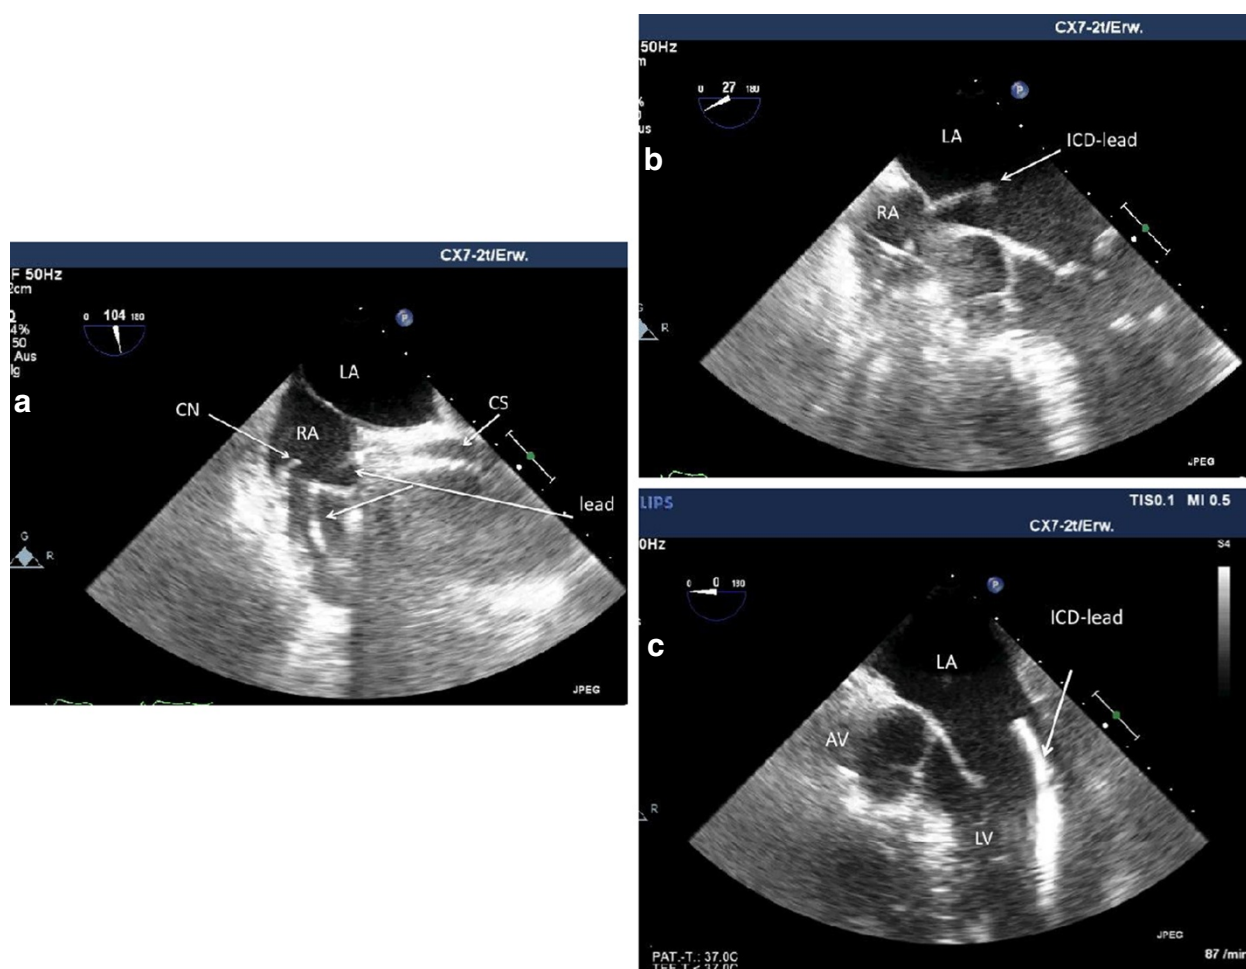
One month later on follow-up, the patient reported a marked improvement of his exercise capacity (NYHA II). Electrode values remained stable. An unscheduled echocardiogram (Philips iE33) revealed a marked reduction of left ventricular dimensions with an improved mono-plane ejection fraction (51%). However, through the mitral valve leaflets a thick electrode proceeded into the apex of the left ventricle. An additional transesophageal echocardiographic examination demonstrated the coronary sinus (CS) electrode in place (Figure 3a) but a malposition of the RV electrode passing the patent foramen ovale (PFO) via an Eustachian valve into the left ventricle (3 b-d).

**Figure 3** Transesophageal echocardiographic recordings after the original implantation procedure. The LV electrode (lead) is placed in the coronary sinus (CS), Chiari's network (CN) present in the right atrium (RA) (**3 a**); the ICD electrode (ICD lead) passes the atrial septum via the foramen ovale (**3 b**) into the left atrium (LA) and ventricular (LV) apex (**3 c**).
