CASE REPORT

Non infective severe aortic paravalvular leakage 7 years after surgery: the role of suture technique

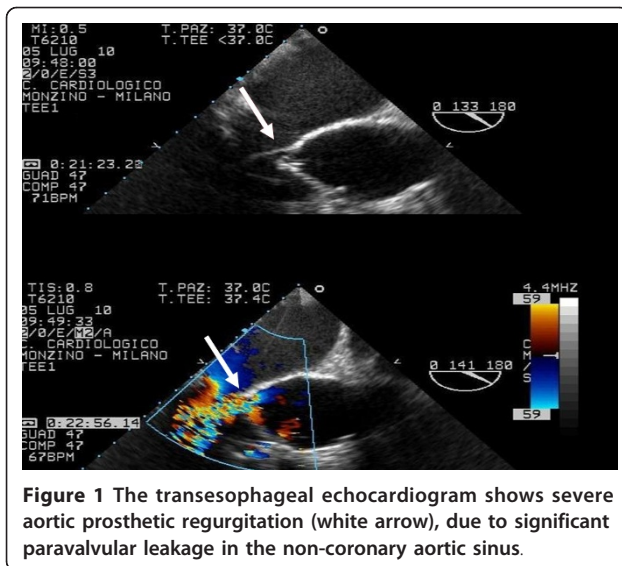
Figure 1 The transesophageal echocardiogram shows severe aortic prosthetic regurgitation (white arrow), due to significant paravalvular leakage in the non-coronary aortic sinus.

A yearly transthoracic echocardiography (TTE) follow-up didn't show any pathological findings. The TTE, performed as soon as the patient was admitted to Emergency Room (ER), revealed a severe aortic regurgitation due to a PVL. The ejection fraction was normal but the left ventricle was dilated: indexed end diastolic volume (iEDV) 107 ml, indexed end systolic volume (iESV) 45 ml. The transesophageal echocardiogram (TEE) confirmed the severe aortic regurgitation, showing an aortic non coronary sinus PVL with a partial detachment of aortic prosthesis. Figure 1 clearly documents the PVL.

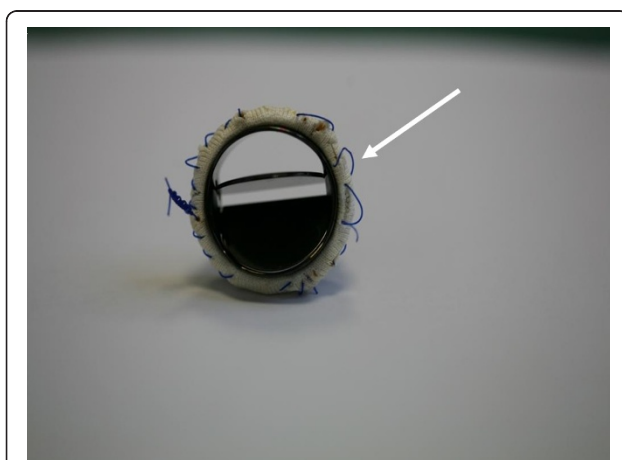
After the sternum reopening and adhesions dissection, the ascending aorta tube graft was opened. The surgical findings confirmed a partial prosthesis detachment at the level of the non coronary aortic sinus, due to the semicontinuous suture breaking (Figure 2). The other two sutures of the left and right coronary sinuses were intact. After the prosthesis explant, a new aortic mechanical prosthesis was implanted (23 mm S. Jude, S. Jude Medical, St. Paul, MN, USA), using interrupted suture technique with 2-0 Ethibond (Ethicon) polytetrafluoroethylene (Teflon)-buttressed stitches. The Teflon buttresses were positioned in the ventricular aspect of the annulus. The postoperative TEE showed normal

Figure 2 The aortic mechanical prosthesis shows a partial detachment at the level of the non-coronary aortic sinus. The semicontinuous suture was broken (white arrow) and the knot was loose. In the picture only one knot is visible since the last one was cut to make possible the aortic prosthesis explant.

For this reason an interrupted suture technique, as we usually do in our Department, could be the best choice to avoid a sudden, severe and sometimes life threatening complication as the rupture of almost one third of annulus suture line.
