CASE REPORT

Repair of left ventricular driveline tear in a SynCardia-total artificial heart patient

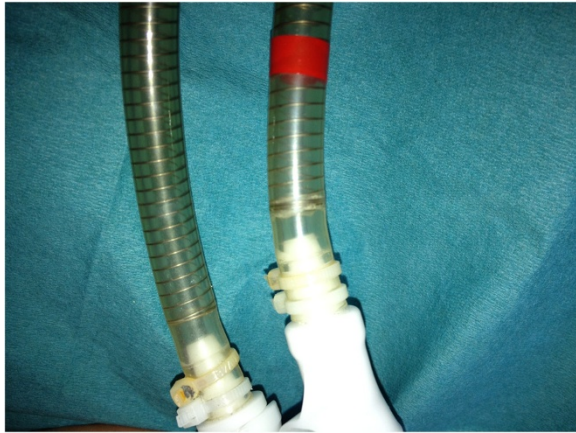
Figure 1 Small horizontal tear at the left ventricular driveline.

uneventful. The patient was switched to the Freedom driver and was discharged at home. The patient was re-admitted at postoperative day 172 due to progressive exertion intolerance caused by an air leak at the left ventricular driveline. Radiology showed mid-severe pulmonary congestion. Upon inspection, we noted a small horizontal tear above the connection of the driveline to the air tubes (Figure 1). After cutting through both cable ties that secure the drivelines with the connectors using a Xcelite 170 M general purpose shear cutter (Apex tool group, Sparks, MD, USA) (Figure 2) we cut off the left driveline slightly above the location of the tear with a high leverage cable cutter (Klein Tools, Lincolnshire, IL, USA) (Figure 3) and quickly switched the patient to a Companion Driver operating in a standard Intensive Care Unit Mode. The whole procedure was completed in approximately 5 minutes. Throughout the procedure the patient showed no clinical signs such as syncopal spell. Two days later the patient recompensated fully. He was switched to a Freedom Driver and discharged at home. Mechanical support of the patient is still ongoing.

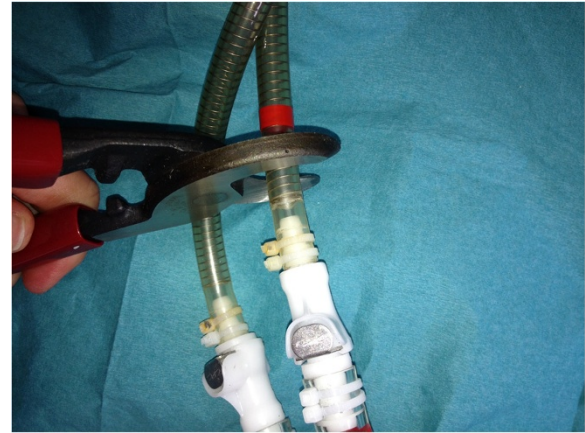
Figure 3 Cutting off the left driveline with the high leverage cable cutter.

intolerance. Therefore it is important to identify and repair quickly the defect. Other currently available repair techniques include banding the driveline with a silicon tube [3] or sealing it with cyanoacrylate adhesive. However this is only a provisory repair. Since the U.S. Food and Drug Administration (FDA) has approved a Humanitarian Use Device (HUD) designation for the SynCardia temporary Total Artificial Heart to be used for destination therapy in patients not being eligible for transplantation [4] and since the durability of the driveline could limit successful long-term support [5], the aim should be to definitively repair any driveline defect. As in this case, the repair can be easily facilitated by cutting the driveline at the location of the tear and reconnecting to the air tubes. During repair

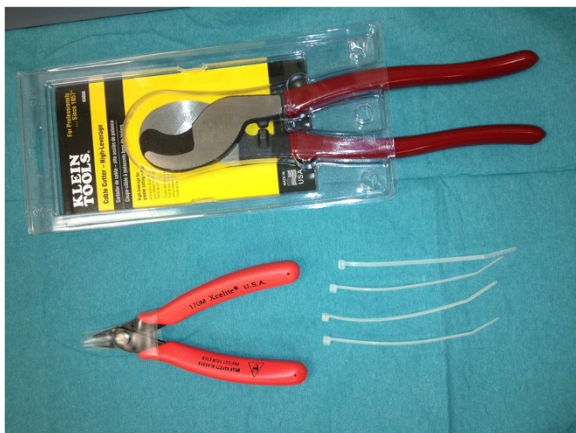
Figure 2 Set of tools: Xcelite 170 M general purpose shear cutter (Apex tool group, Sparks, MD, USA), high leverage cable cutter (Klein Tools, Lincolnshire, IL, USA), cable ties.
