RESEARCH ARTICLE

# Is distortion of the bioprosthesis ring a risk factor for early calcification?

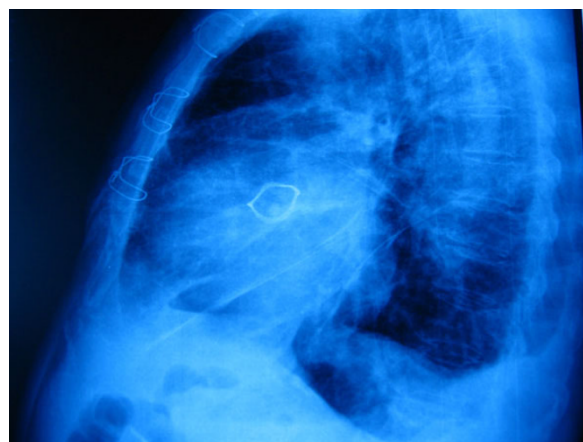
**Figure 1** Radiographic evaluation showed a misshapen bioprosthesis ring.

Chest radiography (Figure 1) showed in all patients an irregular, non- circular bioprosthesis ring. At preoperative coronary angiography a distorted bioprosthesis ring was detected in all patients (Figure 2). An explanted bioprosthesis with leaflet distortion and right coronary leaflet calcification is shown in Figure 3.

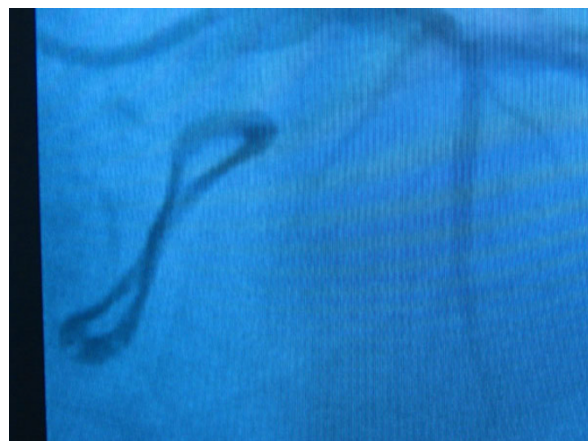
**Figure 2** Preoperative coronary angiography showed a misshapen bioprosthesis ring.

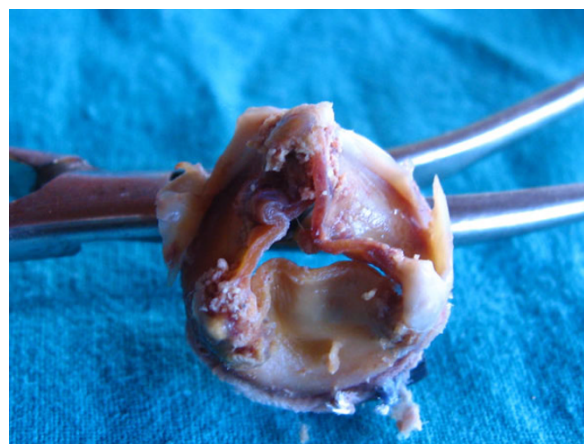
**Figure 3** Explanted bioprosthesis with leaflet distorted and calcification.

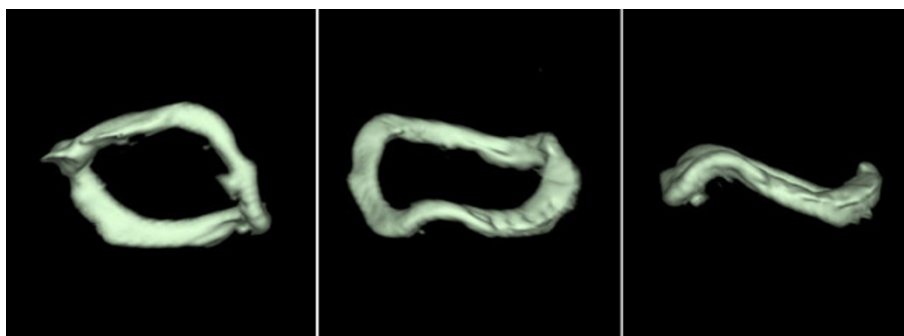
**Figure 4** Three different views of the bioprosthesis ring at MDCT.

In two patients with normal bioprosthesis, the morphology of the leaflets and the degree of excursion were normal at MDCT, but a leaflet had a wave movement. The distorted ring was observed in these patients (Figure 4) and the same picture was observed in two patients with SVD.
