CASE REPORT

Multiple paravalvular leak 17 years after a second mitral valve replacement

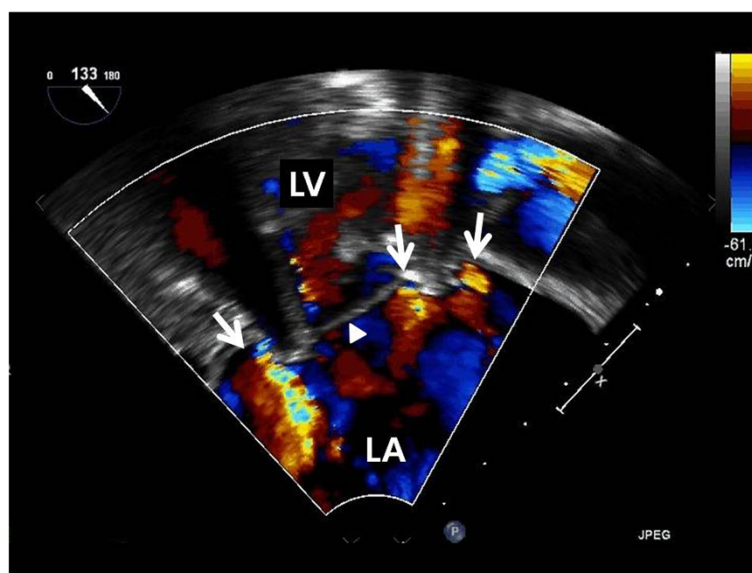
TTE revealed severe mitral regurgitation and moderate tricuspid regurgitation. The pulmonary artery pressure was 45 mmHg, and the left ventricular ejection fraction was 56%. Transesophageal echography (TEE) revealed PVL in multiple areas (Figure 1). Mitral regurgitation due to the PVL, causing heart failure and hemolytic anemia, was diagnosed, and we performed repeat open heart surgery for valve replacement.

Figure 1 Preoperative echocardiographic finding shows multiple paravalvular leaks in the mitral valve. The arrow indicates multiple mitral regurgitant flow and the arrow head indicates the mechanical mitral valve (LA, left atrium; LV, left ventricle).

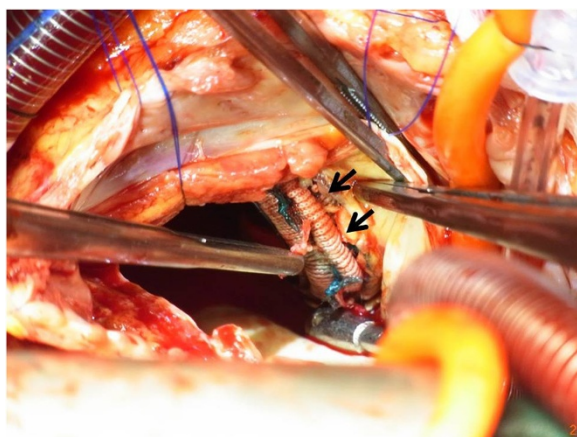
sutures were neither cut nor loosened. The sewing cuff was floated over the native annulus in multiple areas and lead to paravalvular leakage (Figure 2).

Figure 2 Intraoperative finding shows the paravalvular leak area (arrow). The sewing cuff was floating over the native annulus.

We planned to replace it with a new prosthesis instead of repairing it because the dehiscence sites were multiple and the remaining sutures looked weak. The valve was easily removed (Figure 3) and replaced with a new mechanical prosthesis (27 mm, ATS Medical, Inc.; Minneapolis, MN, USA) in the same annular position. The slightly deep everted mattress sutures were done while avoiding injury of important adjacent tissue. After closing the atrial septum, a tricuspid valve annuloplasty was performed with a ring (30 mm, MC3 ring, Edwards Lifesciences, Irvine, CA, USA). The cross-clamp time

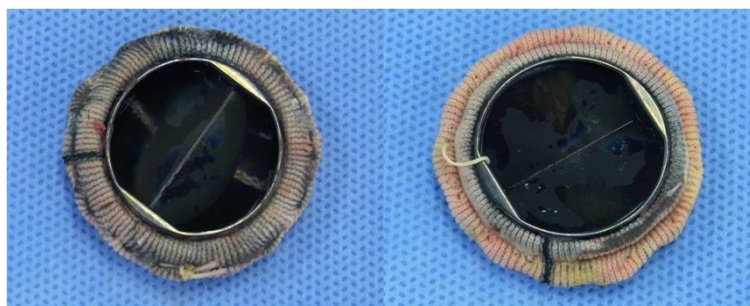
Figure 3 Postoperative findings of removed valve. Not the entire sewing cuff of the mitral valve was covered with tissue, and the valve was removed easily. (Left, left atrial side; Right, left ventricular side).

The only unusual finding was that not all of the entire sewing ring was covered by tissue, which was different than what is usually found in repeat operations and the sewing cuff was floated over the native annulus in multiple areas without cutting or loosening.
