CASE REPORT

Pacemaker lead malpositioning led to subsequent ischemic strokes despite antiplatelet and anticoagulation therapy

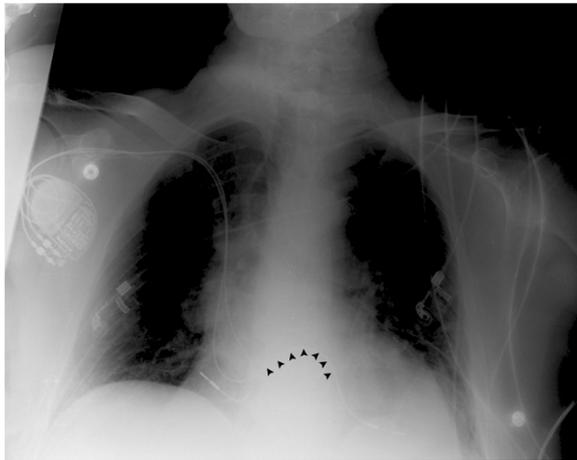
Figure 1 Chest X-ray. The ventricular pacemaker lead follows an unusual course (black arrows) due to its placement via a PFO into the left ventricle.

The patient was primarily loaded with 325 mg acetylsalicylic acid and low-molecular-weight heparin. The oral diabetes medication was stopped. Since the stroke occurred under the therapy with acetylsalicylic acid, it was replaced by clopidogrel (75 mg per day). Additionally, low-molecular-weight heparin (LMWH) in therapeutic dose was prescribed. The pacemaker control showed inconspicuous parameters. The pacing thresholds, the impedance of the electrodes and the sensing were normal. A self-limiting episode supraventricular tachycardia was recorded, another episode occurred during the control. Diagnostic assessment of cardiac risk factors was done. A chest X-ray gave a first hint for a problem with the ventricular lead, since it was deflected and followed an unusual course (Figure 1). Transesophageal echocardiography revealed a patent foramen ovale (PFO) with a diameter of 8 mm and malpositioning of the ventricular pacemaker lead. This lead was unintentionally malpositioned via the PFO into the left ventricle. The atrial lead was correctly placed at the bottom of the right atrium (Figure 2). Echocardiography didn't reveal any thrombotic material on the ventricular lead.

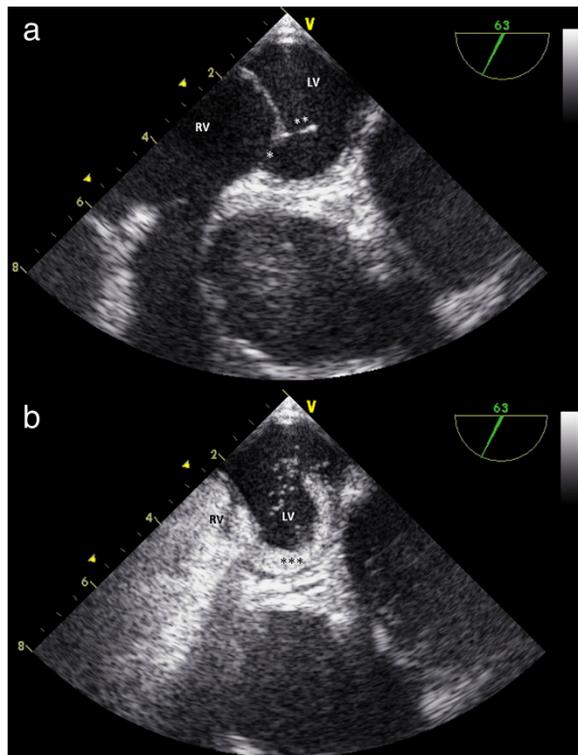
Figure 2 a and b: Transoesophageal echocardiography revealed a PFO. LV left ventricle; RV right ventricle; * PFO, 8 mm; ** pacemaker lead; *** contrast agent.

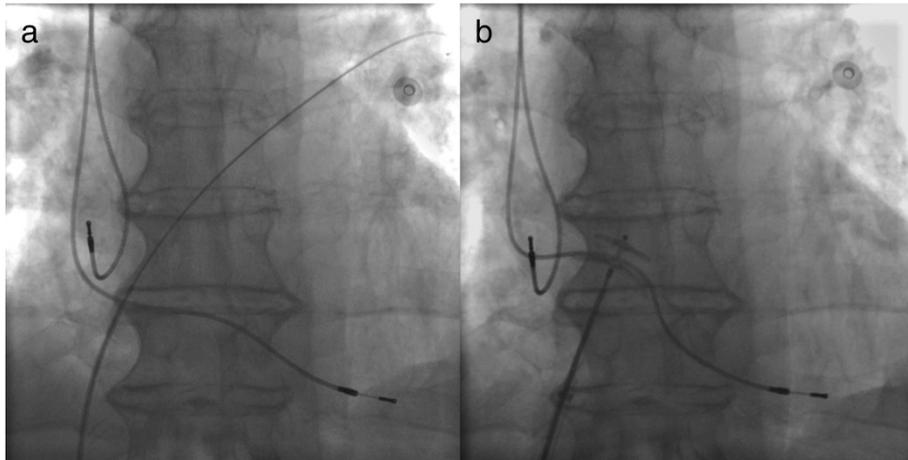
Figure 3 a and b: Chest fluoroscopy. A few days after the re-positioning of the ventricular lead, the PFO was closed with a 25 mm Amplatzer® Septal Occluder.

into the right ventricle. A few days later, the PFO was closed with a 25 mm Amplatzer® Septal Occluder in a second session (Figure 3). After an uneventful postoperative course, the patient was transferred to a peripheral hospital for neurorehabilitation.

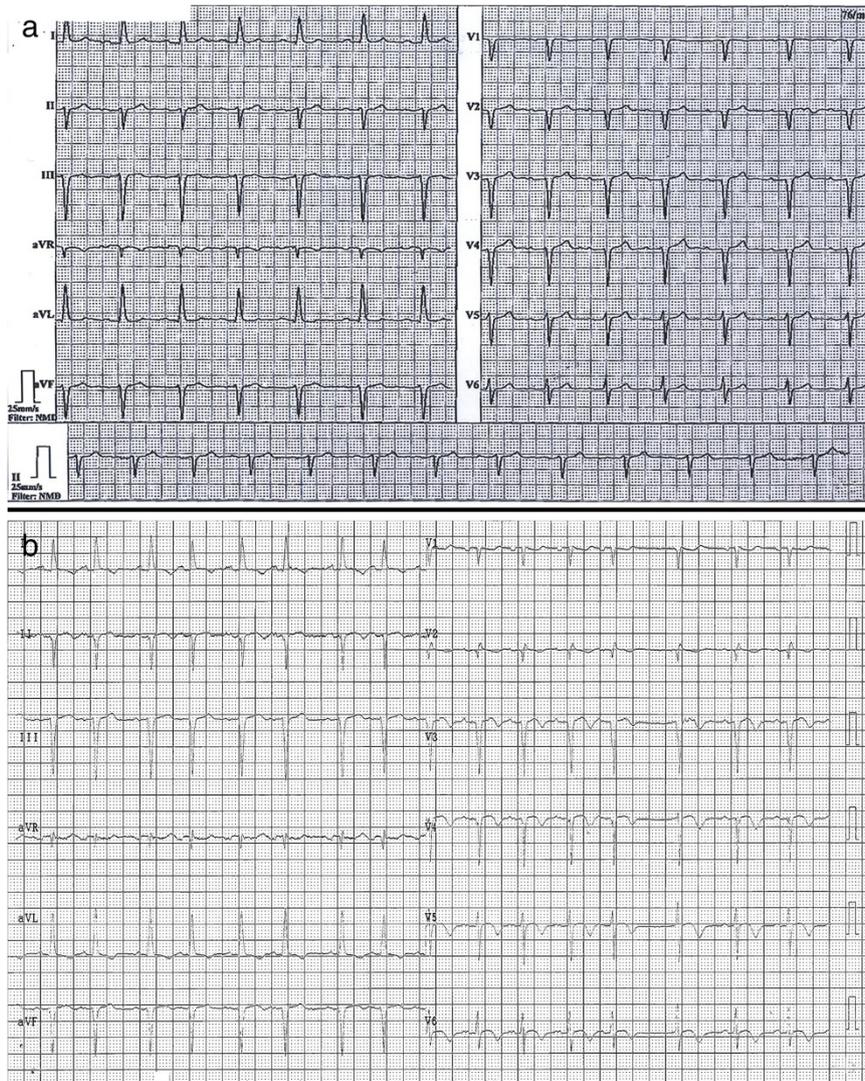
Figure 4 a and b: ECGs before and after repositioning of the ventricular pacemaker lead did not show any signs for pacemaker lead malpositioning.

In our patient, the ECG did not show any alarming abnormalities after the initial pacemaker implantation. It was classified as Sinus rhythm at 76 bpm with left axis deviation. PQ-interval, QRS complex, ST-segment and QT-interval were within a normal range. A left anterior fascicular block was diagnosed. Myocardial ischemia of the posterior wall was known from the patient's medical history (Figure 4a). After repositioning of the lead, the ECG was interpreted as Sinus rhythm at 95 bpm with left axis deviation, left anterior hemi block and repolarisation disorder (Figure 4b).
